# Incident Overview & Claim Information

Sample report for John Doe | Fictional Data

## Property Damage Documentation Report

Prepared by ClaimPrep Technologies LLC

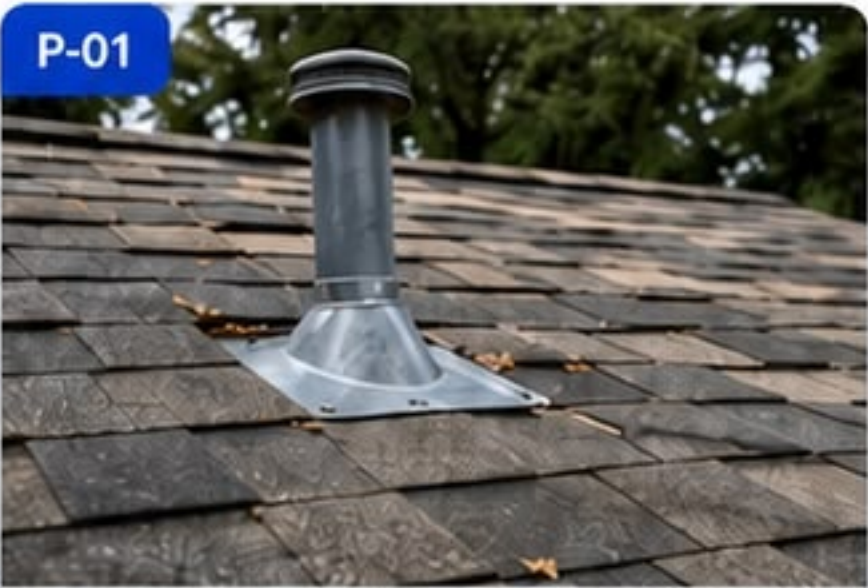
Roof – Rear Section

Displaced shingles and worn flashing near vent pipe; probable water entry point.

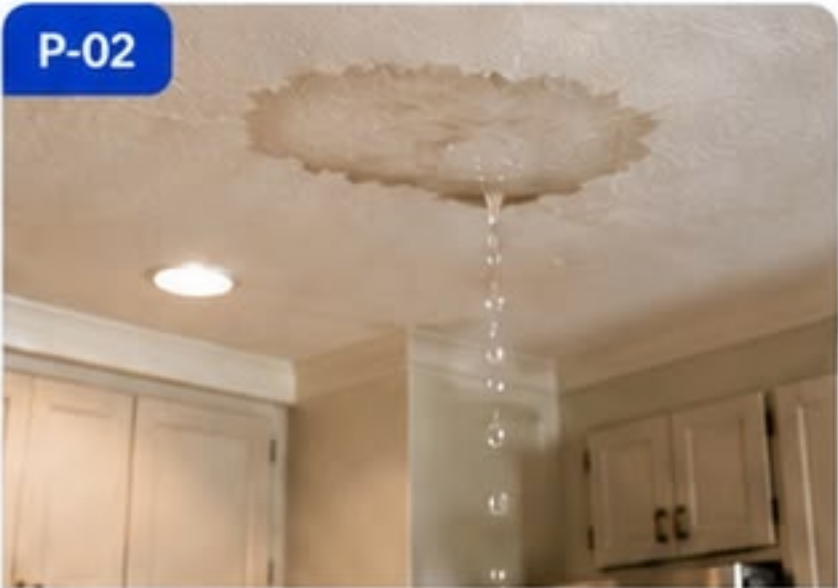
Kitchen – Ceiling

Active drip and water staining on ceiling drywall.

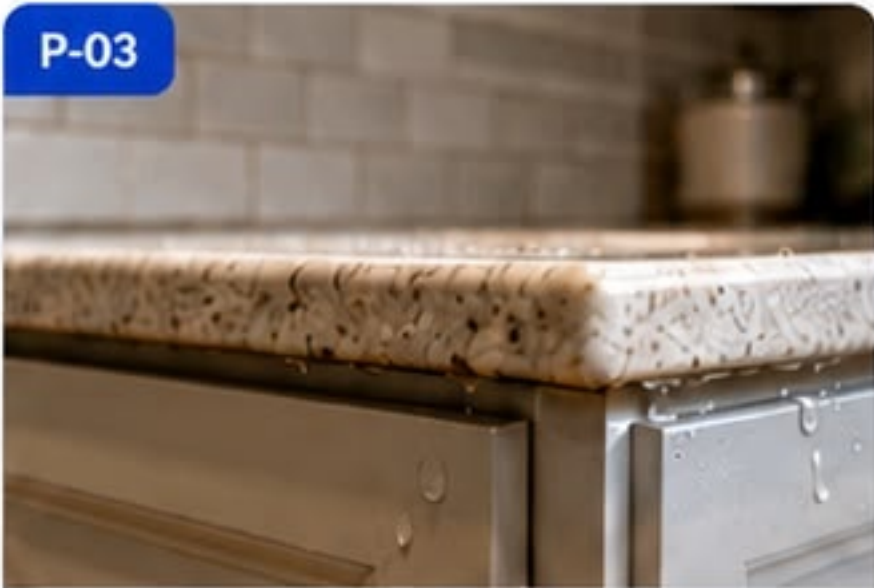
Kitchen – Cabinet & Countertop

Moisture on cabinet edge and countertop surface.

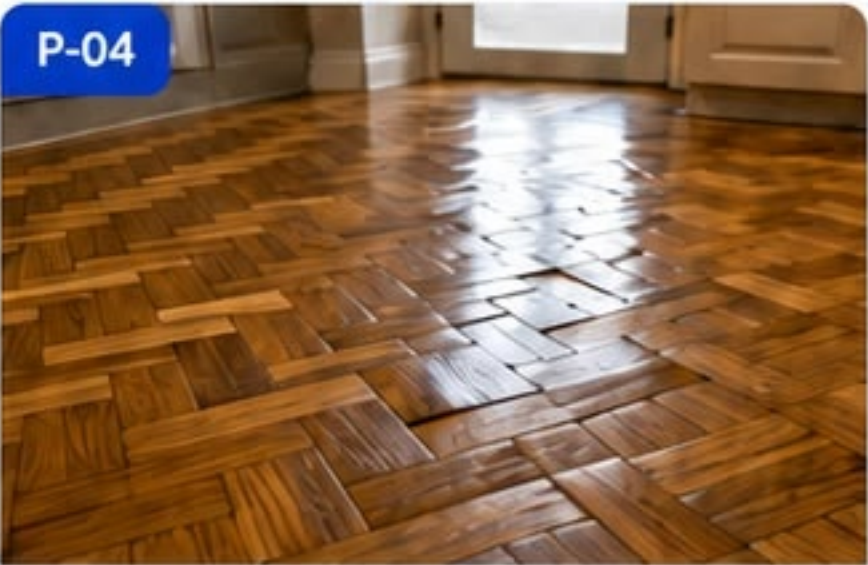
Kitchen – Parquet Flooring

| Area | Condition Observed | Severity |
|---|---|---|
| Parquet flooring in kitchen walkway | Surface wetness, cupping/warping beginning | <span></span> Moderate |

Parquet flooring showing cupping and elevated seams due to moisture exposure.

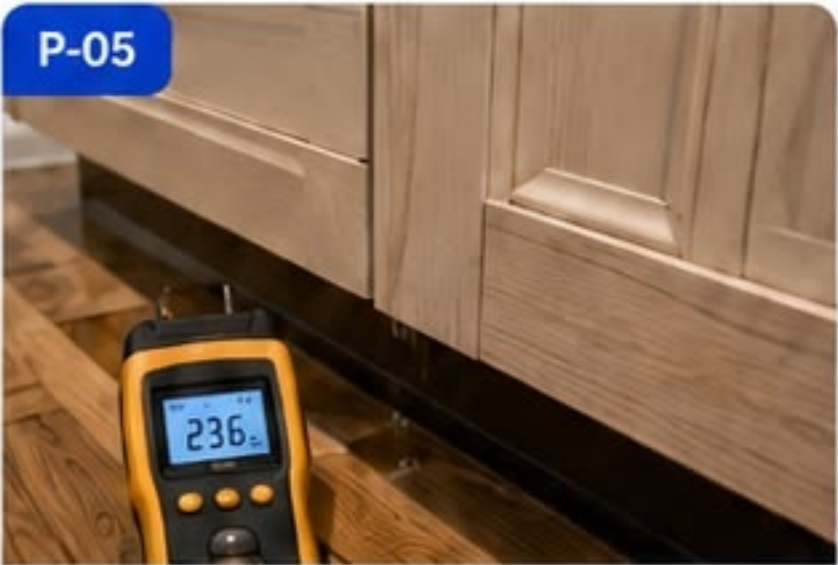
Kitchen – Baseboard Area

| Area | Condition Observed | Severity |
|---|---|---|
| Baseboards near kitchen entrance | Dampness and minor swelling | <span></span> Minor to Moderate |

Elevated moisture reading detected at baseboard and toe-kick area.

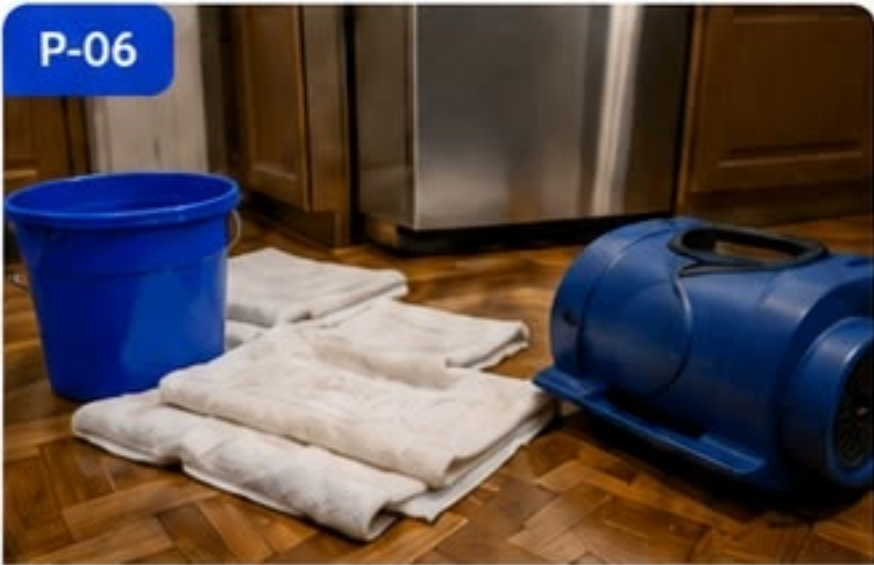
Kitchen – Containment Area

Bucket, towels, and containment measures placed to reduce further damage.
